ELECTRICAL SAFETY FOLLOW UP INSPECTION REPORT (13TH)

Factory Name	Raidha Collection Ltd.					Note:
Address	Habirbari, Zamirdia, Valuka, Mymensingh					
FACTORY ID	11304	ELECTRICAL SAFETY INSPECTION DATES				Other Factory: ----- ----- ----- ----- ----- -----
Initial Inspection Date	06-Aug-2014	Date of 5 th Follow Up	07-Nov-2016	Date of 11 th Follow Up	13-Nov-2018	
Report Received Date	25-Sep-2014	Date of 6 th Follow Up	10-Jan-2017	Date of 12 th Follow Up	11-Apr-2019	
Date of 1 st Follow Up	24-Aug-2015	Date of 7 th Follow Up	10-Apr-2017	Date of 13 th Follow Up	22-Jul-2019	
Date of 2 nd Follow Up	22-Feb-2016	Date of 8 th Follow Up	20-Jul-2017	Date of 14 th Follow Up		
Date of 3 rd Follow Up	26-Apr-2016	Date of 9 th Follow Up	14-Dec-2017	Date of 15 th Follow Up		
Date of 4 th Follow Up	22-Aug-2016	Date of 10 th Follow Up	18-Jul-2018	Date of 16 th Follow Up		
Inspected by		Banna Kasemi

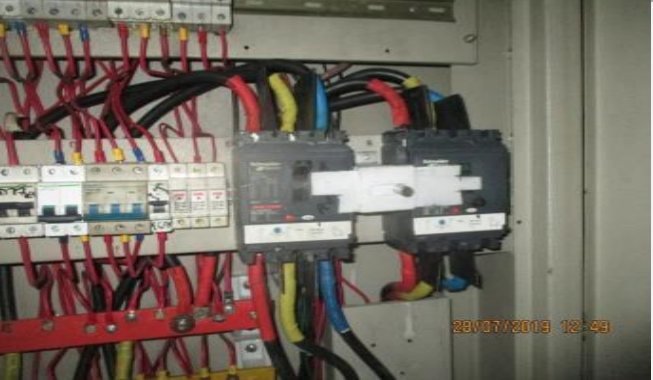
Item No	Accord Inspection Observation	Accord Action Plan (Recommendation)	Accord Time line (given in report)	Comments from Accord (After Physical Inspection)	Final Timeline (Approved timeline)	Final Action Plan (Factory)	Progress Status (On the date of inspection)	Pictorial Evidence
78	New Finding: Interlocking is not provided for powering common busbar from different sources.	Interlocking must be provided for feeding power from multiple sources.	1 Month	On 22/07/2019: Corrected.	21-May-2019	Done	Corrected

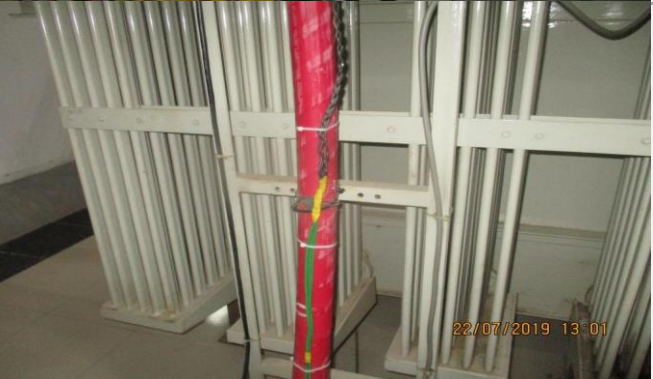
79	New Finding: HT leakage current collector is not connected with earthing system.	HT leakage current collector must be connected with earthing system with adequate size earthing cable.	1 Month	On 22/07/2019: Not Corrected. Need to increase conductor size (collectively).	21-May-2019		In Progress

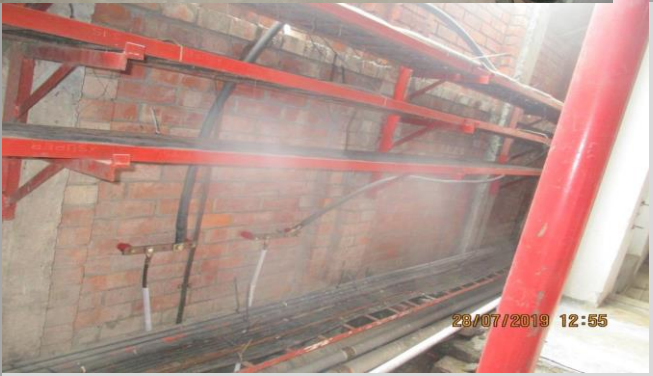
Item No	Accord Inspection Observation	Accord Action Plan (Recommendation)	Accord Time line (given in report)	Comments from Accord (After Physical Inspection)	Final Timeline (Approved timeline)	Final Action Plan (Factory)	Progress Status (On the date of inspection)	Pictorial Evidence
96	New Finding: Outdoor cable tray/ladders are not protected.	Outdoor cable tray/ladders shall be covered properly to avoid seasonal effect on cables and its longevity.	1 Month		30-Sep-2019
