**FIRE SAFETY FOLLOW UP INSPECTION**

| <b>Factory Name</b> | Raidha Collections Ltd. | | <b>Accord ID</b> | 11304 |
| <b>Address</b> | Habirbari, Zamirdia, Valuka, Mymensingh. | | | |

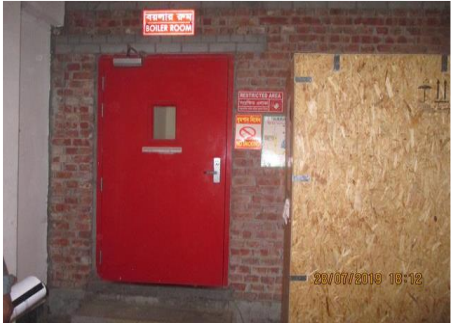
| 1 | The generator, boiler & transformer rooms are not separated by fire-rated construction (openings, non-rated doors, penetrations) on the ground floor. | Separate the generator, boiler & transformer rooms by a minimum 2-hr fire-rated construction. Seal and/or protected all openings to maintain the required fire separations | Within 3 months | <p>On 10/01/2017: Partially corrected. Boiler &amp; Generator: Corrected. Required fire separation has been provided. Transformer: Work in progress. Fire door installation is balanced.</p> <p>On 10.04.2017: Corrected as per site observation. Proper separation has been provided by fire rated construction.</p> <p>On 20/07/2017: Corrected</p> <p>On 14/Dec/2017: Corrected</p> <p>18-07-2018: Corrected on previous follow-ups.</p> <p>On 13/11/2018: Corrected</p> <p>On 21/04/2019: Corrected.</p> <p><b>On 28/07/2019: Corrected.</b></p> | 30-May-2016 | Done | Corrected | |

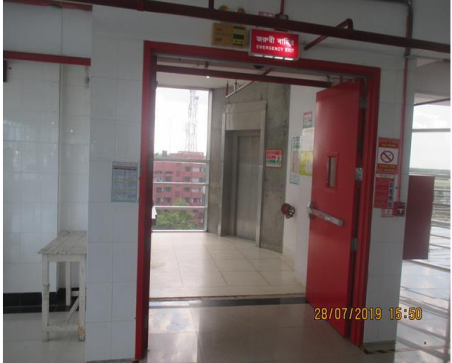
| 2 | The exit stairs are not separated from work areas on each floor by fire-rated construction. | <p>Provide minimum 1.5-hr fire rated doors and seal all unprotected openings to separate the exit stairs from work areas and other building spaces on all floor levels.</p> <p>Ensure that the fire doors are self-closing and positive latching and that they are provided with fire exit (panic) hardware where serving production floors.</p> <p>If fire doors are required to be held open for functional reasons, provide automatic closing devices tied to the fire alarm system.</p> | Within 3 months | <p>On 10/01/2017: Work in progress. Civil work and fire door installation is ongoing.</p> <p>On 10.04.2017: Factory management has installed 41nos fire doors and opened LC for 13nos fire doors.</p> <p>On 20/07/2017: Corrected.</p> <p>On 14/Dec/2017: Corrected as per previous follow up.</p> <p>18-07-2018: Corrected on previous follow-ups.</p> <p>On 13/11/2018: Corrected</p> <p>On 21/04/2019: Corrected.</p> <p><b>On 28/07/2019: Corrected.</b></p> | 30-May-2016 | Work done according to Accord guide line. | Corrected | |

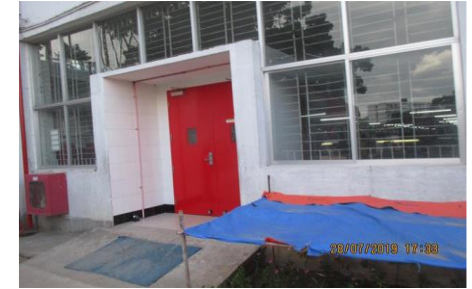
| 7 | Sliding doors are provided at building exits & exit stairs on every floor. | Replace all sliding doors along the means of egress with sidehinged, swinging egress doors. If locks are required for security reasons, utilize special door locking features complying with NFPA 101. | Within 1 months | <p>On 22/02/16: Completed<br/> On 26/04/16 : Corrected.<br/> On 22/08/2016: Corrected. No non-compliant gates were found during the time of inspection.<br/> On 07/11/2016: Corrected.<br/> On 10/01/2017: Corrected.<br/> On 10.04.2017: Corrected as per site observation.<br/> On 20/07/2017: Corrected<br/> On 14/Dec/2017: Corrected<br/> 18-07-2018: Corrected on previous follow-ups.<br/> On 13/11/2018: Corrected<br/> On 21/04/2019: Corrected. Replaced.</p> | 25-Apr-2015 | Done | Corrected | |

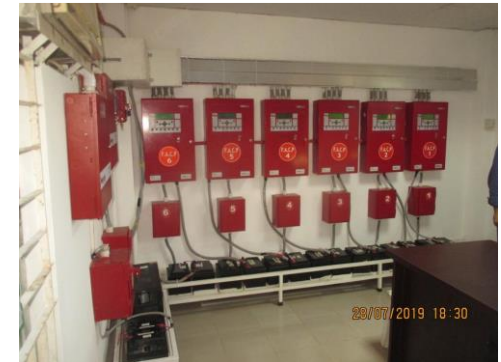
| 8 | The fire alarm system is antiquated, not a listed system, and does not provide alarm and notification features consistent with acceptable standards. | Replace the fire alarm system with a new, listed addressable fire alarm system in accordance with NFPA 72. | Design within 4 months, install within 9 months | <p>On 18-07-2018: During the time of testing and commissioning, the factory was found unprepared for T&amp;C. Modification work is on-going<br/> On 13/11/2018: During the time of testing and commissioning audibility level has been found less in ground, 6th, 7th floor.<br/> On 21/04/2019: Not corrected. During follow up (testing &amp; commissioning) inspection it was observed that modification needed before system being accepted and following observations were found: 1. Audibility needs to be evaluated and corrected in those locations where it is inadequate such as 2nd, 3rd, 4th &amp; 5th floors. 2. Wiring to the fire alarm control panels were not protected against damage.<br/> Battery &amp; voltage drop calculation shall be according to NFPA 72. Wiring diagram shall be provided as the clear indication of As-built condition.<br/> MCP, sounder &amp; detector device shall be provided at all required locations throughout the building in factory premises. Correct documentation is needed to confirm system capabilities for operation on stand-by power. All the deficiencies shall be remediated as soon as possible as per NFPA 72 and Accord standard prior to acceptance test again.</p> | 30-May-2016 | In progress | Corrected | |

**On 28/07/2019:** Corrected. During Testing & Commissioning fire alarm system was functional properly and audibility level is accepted based on the observation along with site condition.

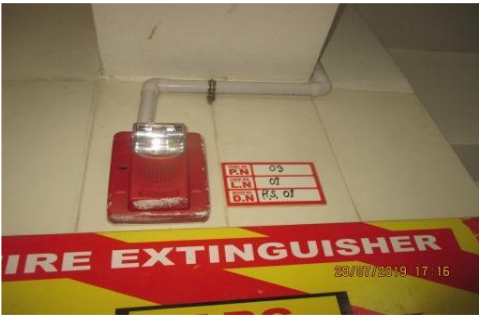
| 10 | Activation of the fire alarm system by a manual fire alarm station provides automatic occupant notification only on the floor of alarm and not throughout the building. Specify alarm sequence / conditions | Configure the fire alarm system to initiate automatic occupant notification on all floor levels to facilitate wholebuilding evacuation upon any manual fire alarm station activation. | Within 1 months | <p>On 20/07/2017: It is an integrated part of Fire Alarm System.</p> <p>On 14/Dec/2017: Integrated part of fire alarm &amp; detection system</p> <p>On 18-07-2018: Integrated part of fire alarm &amp; detection system. During the time of testing and commissioning, the factory was found unprepared for T&amp;C. Modification work is on-going.</p> <p>On 13/11/2018: During the time of testing and commissioning audibility level has been found less in ground, 6th, 7th floor.</p> <p>On 21/04/2019: It is an integrated part of fire alarm system.</p> <p><b>On 28/07/2019: Corrected.</b></p> | 30-May-2016 | In progress | Corrected | |

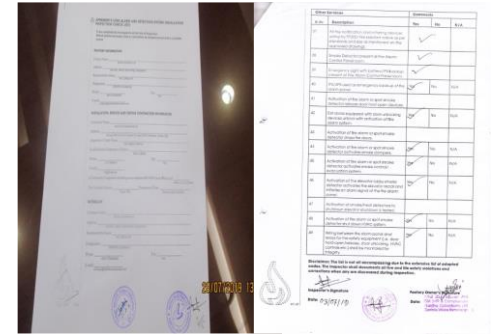
11 Inspection, testing, and maintenance of the fire alarm system is not in accordance with NFPA 72.

On 22/02/16: It is an integrated part of fire alarm system.  
 On 26/04/16: It is an integrated part of fire alarm system.  
 On 22/08/2016: Corrected. Factory is maintaining a standard checklist as per code.  
 On 07/11/2016: Corrected.  
 On 10/01/2017: Corrected.  
 On 10.04.2017: Corrected.  
 On 20/07/2017: Corrected  
 On 14/Dec/2017: Corrected  
 18-07-2018: Corrected on previous follow-ups.  
 On 13/11/2018: Corrected  
 On 21/04/2019: Corrected. Maintaining.

On 28/07/2019: Corrected.

Inspect, test and maintain the fire alarm system, and keep written records on-site, in accordance with NFPA72.

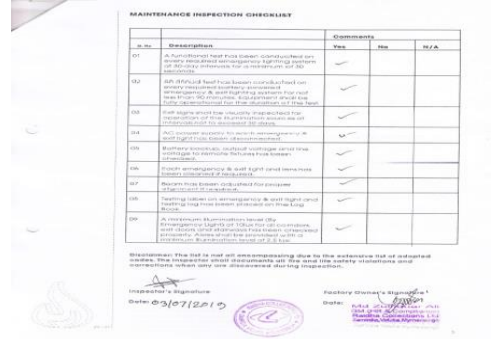
12 Inspection, testing, and maintenance for the emergency lighting system was not in accordance with The ACCORD standard.

On 22/02/16: Completed  
 On 26/04/16: Corrected.  
 On 22/08/2016: Corrected. Factory is following a standard checklist as per code.  
 On 07/11/2016: Corrected.  
 On 10/01/2017: Corrected.  
 On 10.04.2017: Corrected.  
 On 20/07/2017: Corrected  
 On 14/Dec/2017: Corrected as per previous follow up.  
 18-07-2018: Corrected on previous follow-ups.  
 On 13/11/2018: Corrected  
 On 21/04/2019: Corrected. Maintaining.

On 28/07/2019: Corrected.

Inspect, test and maintain the emergency lighting system in accordance with The ACCORD standard. Keep written records on site.

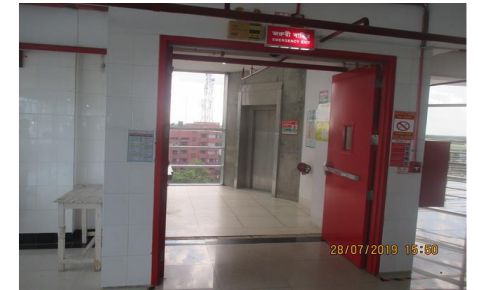
13 New Finding (1st Floor): Exit sign not provided at exit.

On 22/02/16: Completed  
 On 26/04/16 : Corrected.  
 On 22/08/2016: Corrected. Exit signages were found during the inspection.  
 On 07/11/2016: Corrected.  
 On 10/01/2017: Corrected.  
 On 10.04.2017: Corrected as per site observation.  
 On 20/07/2017: Corrected  
 On 14/Dec/2017: Corrected  
 18-07-2018: Corrected on previous follow-ups.  
 On 13/11/2018: Corrected  
 On 21/04/2019: Corrected. Provided.

On 28/07/2019: Corrected.

Lighted exit signs shall be placed at entrance to an exit. Additional exit signs shall be placed throughout the facility anywhere the continuation of the egress is not obvious. Lighted exit signs shall be provided with either battery backup or uninterruptible power supply systems and shall be continuously illuminated.

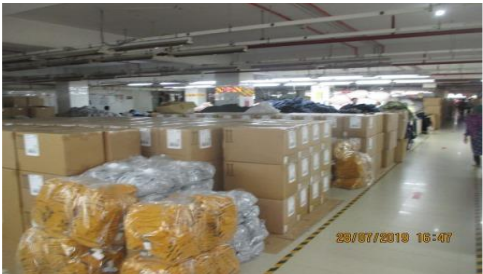
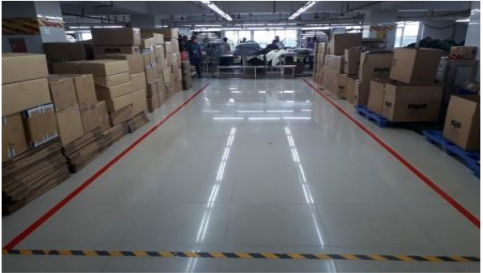
| Item No | Accord Observation | Accord Recommendation | Timeline given by Accord | Comments after Physical Inspection | Supposed to complete (DD/MM/Y YYY) | Final Action Plan (Factory) | Status on the date of Inspection | Pictorial Evidence |
|---|--|--|---|--|---|---|---|--|
| 17 | New Finding (7th Follow-Up): Areas used for in-process storage of combustible materials are open to the surrounding occupancy | Provide defined storage areas and limit the storage arrangement as follows:-<br>1. General Condition:<br>Maximum height of 2.4m and maximum area of 23m <sup>2</sup> .<br>Separate areas of unenclosed combustible storage by a minimum clear distance of 3m.<br>2. If sprinkler protected:<br>maximum height of 3.66m and maximum area of 93m <sup>2</sup> .<br>Separate areas of unenclosed combustible storage by a minimum clear distance of 3m.<br>or<br>3. Enclose the storage area from the surrounding occupancy with a minimum 1 hour construction. | Within 1 months | On 10.04.2017: NEW FINDING.<br>On 20/07/2017: In progress. The current pile shall be covered by sprinkler as the sprinkler issue gets corrected.<br>On -18-07-2018: Not corrected. Huge storage were observed located randomly within production area.<br>On 13/11/2018: Corrected<br>On 21/04/2019: Corrected. Maintaining.<br><br><b>On 28/07/2019:</b> Corrected. Maintaining. | 10-May-2017 | Done According to accord guide line | Corrected | <br> |

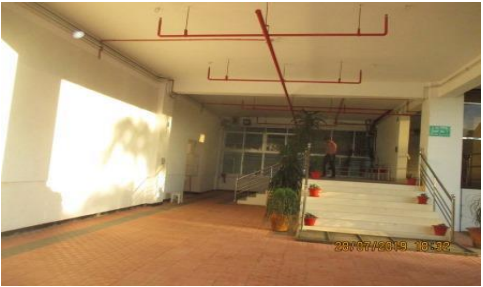
| Item No | Accord Observation | Accord Recommendation | Timeline given by Accord | Comments after Physical Inspection | Supposed to complete (DD/MM/Y YYY) | Final Action Plan (Factory) | Status on the date of Inspection | Pictorial Evidence |
|---|--|--|---|--|---|---|---|--|
| 18 | New Finding (7th Follow-Up): The exit discharge paths serving the North exit stairs were not separated from the building interior. | Seal all penetrations and openings to the interior of the building along the discharge path, up to a height of 10 ft., to provide a minimum 1-hr fire separation.<br>Alternatively, provide a second remote discharge path to the public way (only include this if feasible) | Within 1 months | On 10.04.2017: NEW FINDING.<br>On 20/07/2017: Unprotected opening observed<br>On 14/Dec/2017: In progress<br>On 18-07-2018: Not corrected. Huge modification work pending.<br>On 13/11/2018: In progress<br>On 21/04/2019: Corrected. Sealed.<br><br><b>On 28/07/2019:</b> Corrected. | 10-May-2017 | In progress | Corrected | |

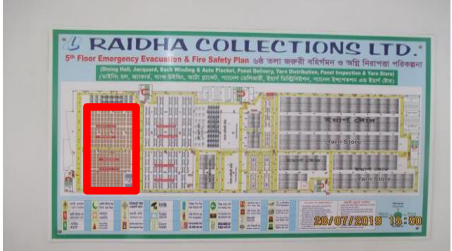
| Item No | Accord Observation | Accord Recommendation | Timeline given by Accord | Comments after Physical Inspection | Supposed to complete (DD/MM/Y YYY) | Final Action Plan (Factory) | Status on the date of Inspection | Pictorial Evidence |
|---|--|--|---|--|---|---|---|--|
| 19 | New Finding (7th Follow-Up): The dining area in the fifth floor is not separated from adjacent production floor area by fire rated construction. | Separate the dining area by a minimum 3-hr fire-rated construction having a direct access to exit stair. Seal and/or protected all openings to maintain the required fire eparations. | Within 2 months | On 10.04.2017: NEW FINDING.<br>On 20/07/2017: In progress.<br>On 14/Dec/2017: In progress. Direct exit access from the dining facilities to the exit stair is not provided yet.<br>On 18-07-2018: Observed same as last follow-up.<br>On 13/11/2018: Corrected<br>On 21/04/2019: Corrected. Factory has provided 2 nos exit direct to exit stair from dining area.<br><br><b>On 28/07/2019:</b> Corrected. | 10-Jun-2017 | Done | Corrected | |

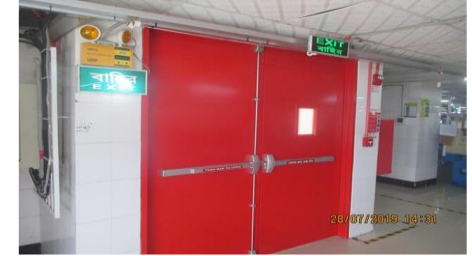
20 New Finding (10th FU): Egress door serving 50 or more occupants but does not swing in the direction of egress travel.

On 18-07-2018: New Finding  
On 13/11/2018: Corrected.  
On 21/04/2019: Corrected.

**On 28/07/2019:** Corrected.

Modify swing direction of egress doors to the direction of egress travel. Doors serving an occupant load of more than 50 shall swing in the direction (out-ward) of egress travel .

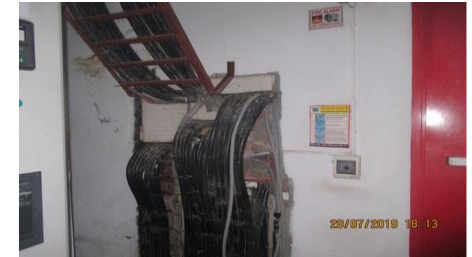
21 New Finding (10th FU): Unsealed penetrations were observed from utility section towards the enclosed exit discharge path.

On 18-07-2018: Corrected.  
On 13/11/2018: In progress. From washing section, unsealed opening was present with the exit discharge path.  
On 21/04/2019: Corrected.

**On 28/07/2019:** Corrected.

Seal all penetrations and openings with rated construction.

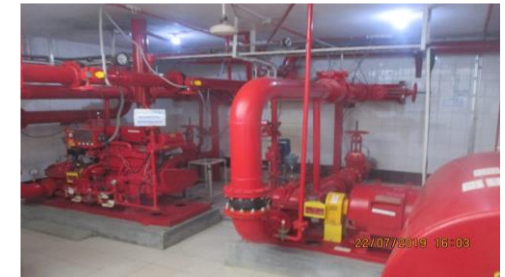
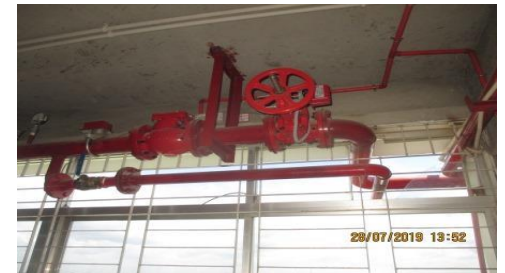
22 New Finding (On 21/04/2019): During follow up inspection following observations were found in fire pump room: 1. Suction line to the diesel pump, and suction line to the electric pump, does not meet NFPA 20 requirements. For each pump, an elbow was present in the line within 10 times suction pipe diameter of the pump suction flange, and a concentric reducer was fixed to the pump suction flange. 2. Water level gauge or supervision not provided in water reservoir. 3. The pressure sensing lines for each pump are not constructed as per standard materials.

**On 28/07/2019:** Corrected. During functional test fire pump (both diesel & electric) performance was found satisfactory.

Install / Modify fire pump according to NFPA 20 & Accord standard. Protection system (sprinkler & standpipe) shall be designed as per NFPA 13, 14 & 20 and Accord standard.
