## Structural Safety Inspection

Factory Name	<b>Raidha Collection Ltd</b>	Accord ID	11304
Factory Address	Habirbari, Zamirdia, Valuka, Mymensingh , N/a , N/a		
Inspection Date	<b>25/06/2014</b>		
Date of Review Inspection	10-Apr-17		
Inspected by	Md. Ismail Hossain Siddiqui & U.S.M. Dilruba Mahmud

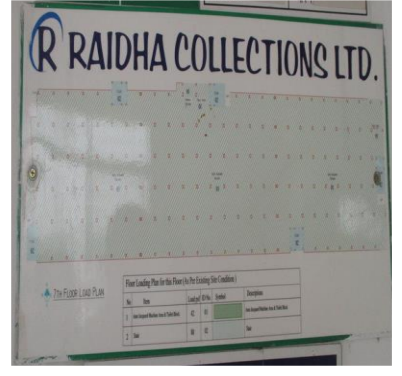
Item No	Accord Observation	Accord Recommendation	Accord Timeline	Final Action Plan	Final Timeline( DD/MM /YYYY)	Comments after Physical Inspection	Progress Status	Pictorial Evidence
3	Cursory calculations indicate columns to be stressed in excess of normal design limits.	<ul style="list-style-type: none"> <li>Produce and actively manage a loading plan for all floor plates within the factory giving consideration to floor capacity and column capacity and foundations.</li> </ul>	Within 6 weeks	DEA report re-submitted to Accord & waiting for final decision.	20/04/2016	<p>On 22/02/2016: They have engaged an Engineering firm to prepare load plan. During inspection no Load plan was found. They were asked to submit the load plan with Engineering assessment report within 25 February, 2016. Load was found below 42 psf in storage areas.</p> <p>On 06/06/2016: During inspection it was observed that load plan was posted in every floor and load was below specified load in load plan.</p> <p>On 10/04/2017: This issue has been corrected as per 2nd follow up inspection. However, during inspection load plan was found posted on each floor and load was below specified load (&lt; 42 psf) in load plan.</p>	Corrected

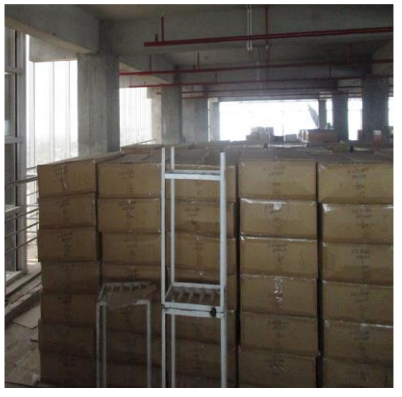
4	Cursory calculations indicate columns to be stressed in excess of normal design limits.	Continue to implement load management plan.	Within 6 months	DEA report re-submitted to Accord & waiting for final decision.	20/04/2016	<p>On 22/02/2016: They have engaged an Engineering firm to prepare load plan. During inspection no Load plan was found. They were asked to submit the load plan with Engineering assessment report within 25 February, 2016. Load was found below 42 psf in storage areas.</p> <p>On 06/06/2016: DEA was accepted on 25 April 2016. Now factory is able to implement load plan. Factory management shall mark the height to maintain exact load.</p> <p>On 10/04/2017: This issue has been corrected as per 2nd follow up inspection. However, during inspection floor load was found below specified load (&lt; 42 psf) in load plan.</p>	Corrected

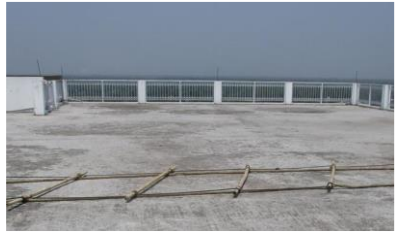
Item No	Accord Observation	Accord Recommendation	Accord Timeline	Final Action Plan	Final Timeline( DD/MM /YYYY)	Comments after Physical Inspection	Progress Status	Pictorial Evidence
10	Lightweight structures	<ul style="list-style-type: none"> <li>• <b>Building engineer</b> to check the capacity of non-engineered lightweight structures under horizontal and vertical loading and make any necessary alterations required.</li> </ul>	Within 6 weeks	Today we will submit the report to Accord.	20/04/2016	<p>On 22/02/2016: This issue will be covered in Engineering Assessment.</p> <p>On 06/06/2016: This issue has been covered in DEA. DEA was accepted on 25 April 2016. During inspection it was observed that retrofitting work of the lightweight steel shed was completed.</p> <p>On 10/04/2017: This issue has been corrected as per 2nd follow up inspection &amp; found same in current.</p>	Corrected	
11	Edge protection to slab edges	<ul style="list-style-type: none"> <li>• <b>Handrails to be</b> provided to all open slab areas or access to be prohibited.</li> </ul>	Within 6 weeks	Handrails are already been provided	16/10/2015	<p>On 22/02/2016: Handrail has been provided.</p> <p>On 06/06/2016: During inspection it was observed that handrail was provided for edge protection.</p> <p>On 10/04/2017: This issue has been corrected as per 2nd follow up inspection &amp; found same in current.</p>	Corrected
